# Manhole Inspection Summary

Manhole # S21II\_028MH

**Location** Address: **1655 MONROE-MCKEAN**

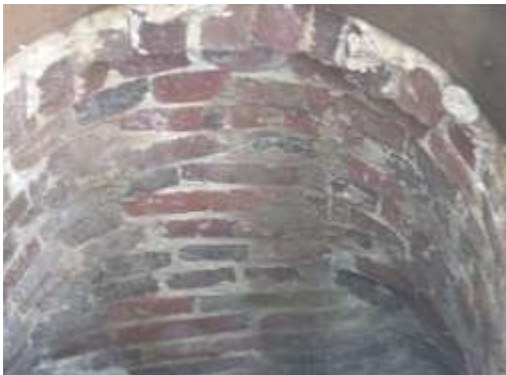
Defect 3

Infiltration: ☐ None ☐ Joint ☐ Cracks ☐ Mortar ☐ Roots ☒ **Wall**

INFILTRATION OF CORBEL

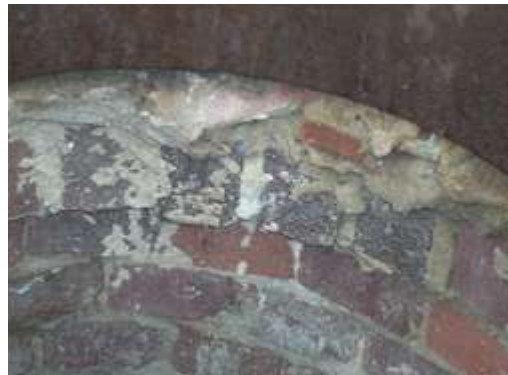
Defect 2

Condition: ☐ Sound ☐ Cracked ☐ Root Intrusion ☐ Loose Brick ☒ **Deteriorated**

DETERIORATION OF CHIMNEY

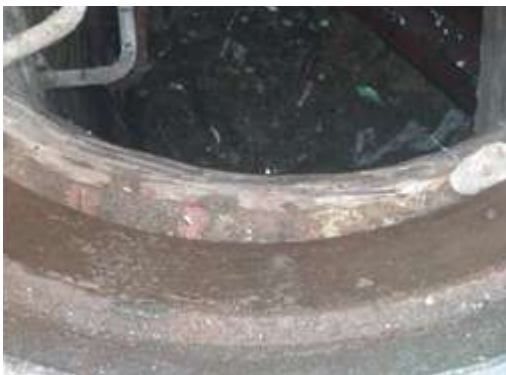
Defect 1

**Frame** Offset: **1** (in.) Condition: ☒ Sound ☐ Cracked ☐ Leaks

FRAME OFFSET

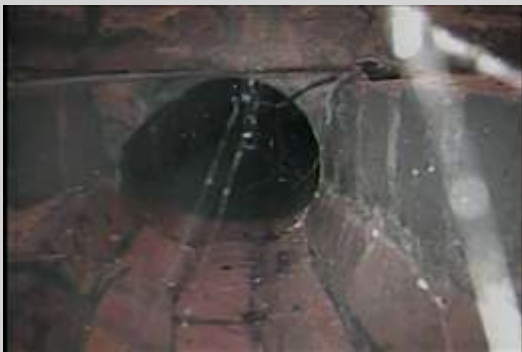
12 O'Clock Outflow

8 in. Circular Gravity Sewer  
Pipe Out @ 12 O'Clock

Pipe Height: **8.4** (in.) Rod and Bar (Angled)  
Pipe Material: **Clay** ☐ Pipe Lined  
Invert Depth: **9.40** (ft.) Flow Characteristics: **Slow**  
Deposits: ☒ None ☐ Mud ☐ Sludge ☐ Debris ☐ Grease  
Silt Depth: (in.) Deposits Extent:  
Infiltration: **None** Pipe Seal Cond: **Sound**

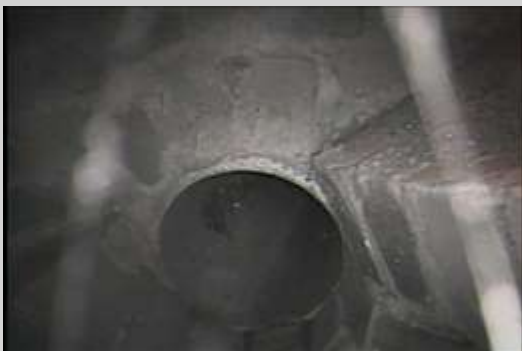
6 O'Clock Inflow

8 in. Circular Gravity Sewer  
Pipe In @ 6 O'Clock

Pipe Height: **8.4** (in.) Rod and Bar (Angled)  
Pipe Material: **Clay** ☐ Pipe Lined  
Invert Depth: **9.31** (ft.) Flow Characteristics: **Slow**  
Deposits: ☒ None ☐ Mud ☐ Sludge ☐ Debris ☐ Grease  
Silt Depth: (in.) Deposits Extent:  
Infiltration: **None** Pipe Seal Cond: **Sound**
